UNITED STATES DEPARTMENT OF AGRICULTURE
BULLETIN No. 379

DUST EXPLOSIONS AND FIRES IN GRAIN SEPARATORS IN THE PACIFIC NORTHWEST

DAVID J. PRICE, Engineer in Charge of Grain Dust Explosion Investigations, Bureau of Chemistry, and E. B. McCORMICK, Chief, Division of Rural Engineering, Office of Public Roads and Rural Engineering

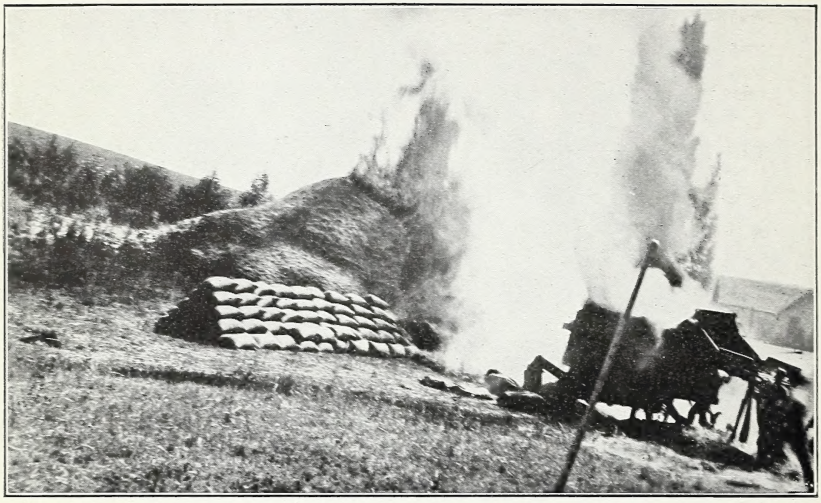
FIG. 1.—SMUT-DUST EXPLOSION IN THRESHING MACHINE IN EASTERN WASHINGTON. PHOTOGRAPH WAS TAKEN AT TIME EXPLOSION AND FIRE OCCURRED.

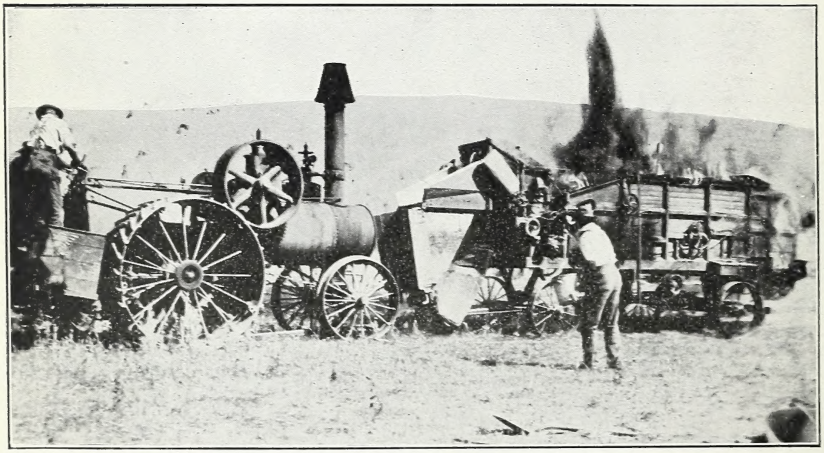
FIG. 2.—ENGINE PULLING A MACHINE AWAY FROM STRAW STACK AFTER EXPLOSION AND FIRE.

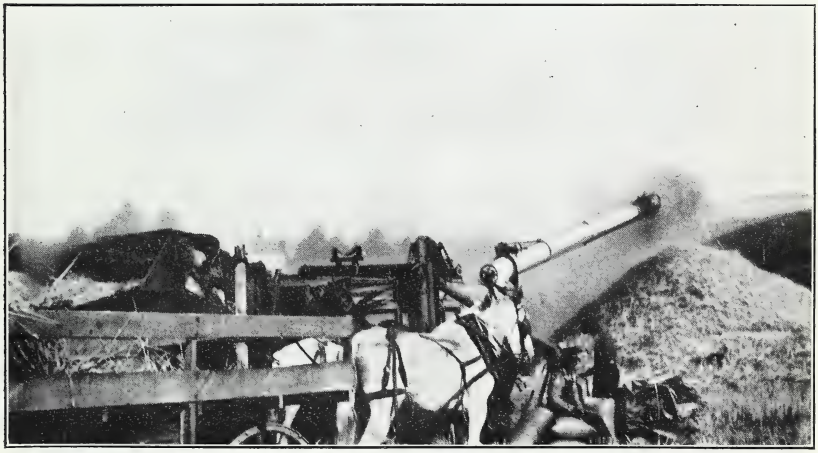
FIG. 2.—SAME MACHINE THRESHING WITH 14 PER CENT SMUT (ESTIMATED) IN CROP, SHOWING BLACKER SMUT-DUST CLOUD COMING FROM BLOWER PIPE.

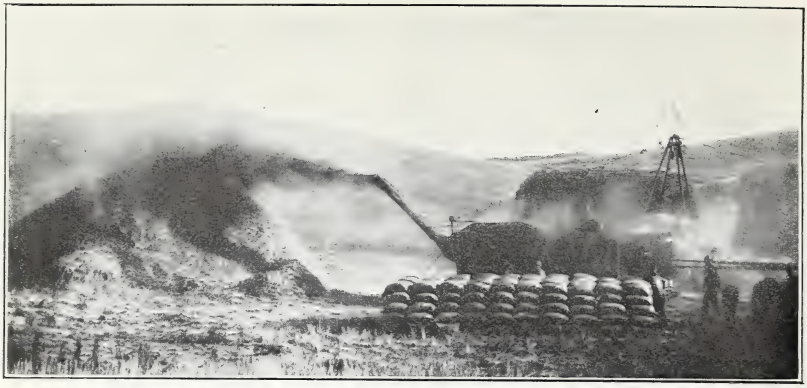
FIG. 1.—BLACK SMUT-DUST CLOUD COMING OUT OF BLOWER PIPE DURING THRESHING OF SMUTTY WHEAT IN EASTERN WASHINGTON.

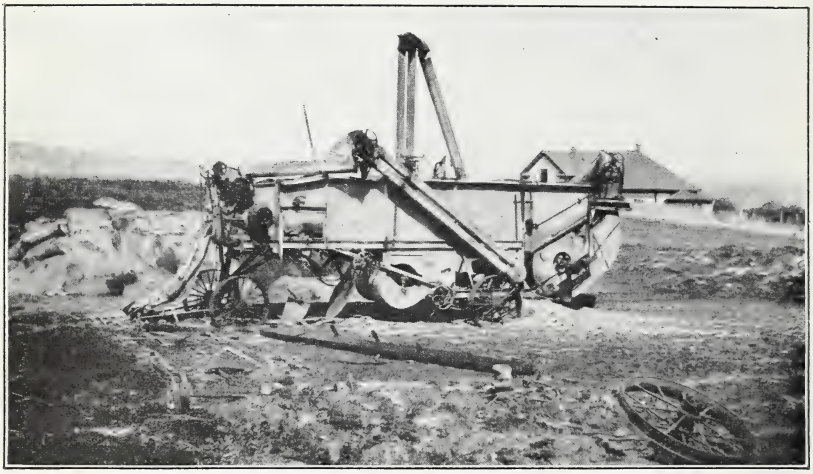
FIG. 2.—STEEL MACHINE BADLY DAMAGED BY SMUT EXPLOSION AND FIRE IN EASTERN WASHINGTON.

FIG. 3.—WOODEN MACHINE COMPLETELY DESTROYED BY SMUT EXPLOSION AND FIRE IN PACIFIC NORTHWEST.

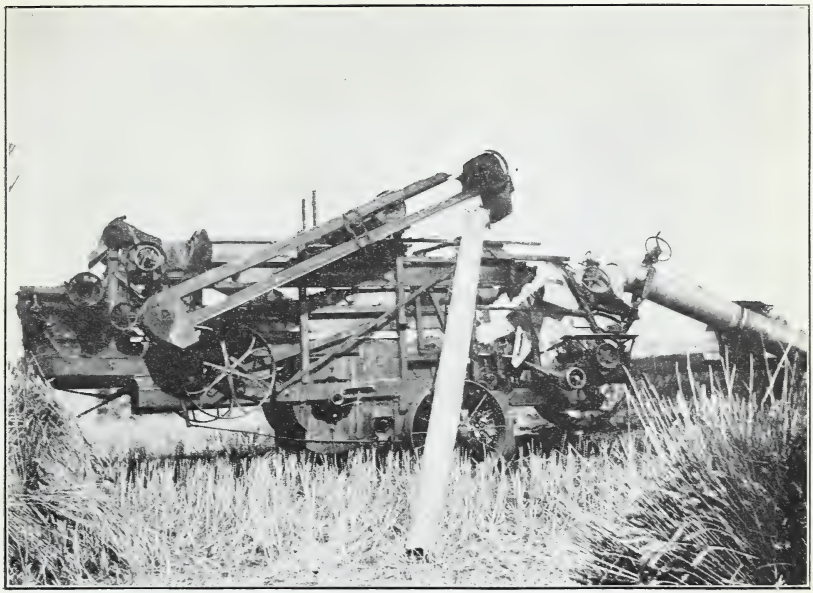
FIG. 1.—WOODEN MACHINE, AFTER EXPLOSION AND FIRE.

FIG. 2.—ANOTHER VIEW OF SAME MACHINE, SHOWING EXTENT OF DAMAGE.

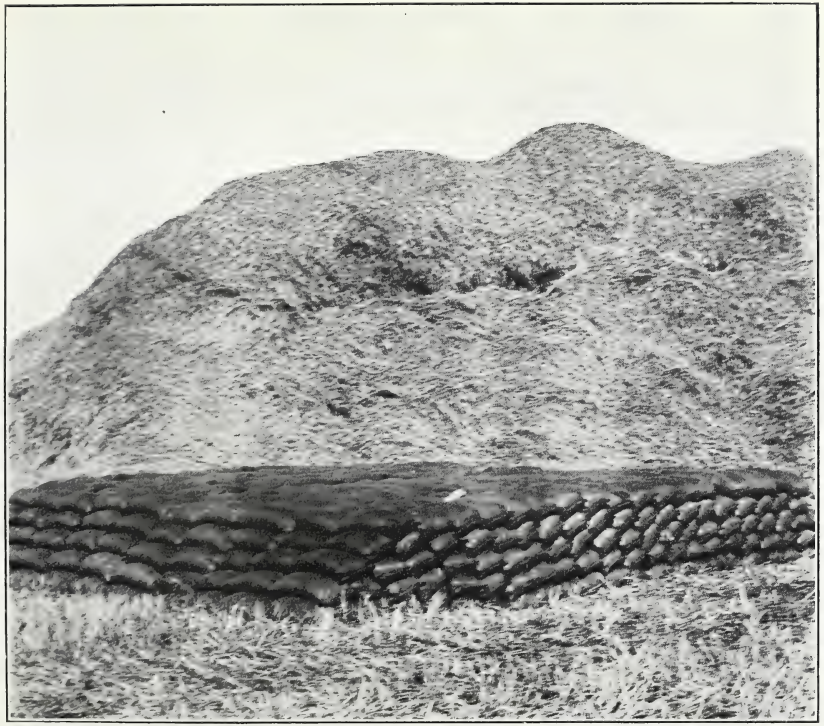
FIG. 1.—PILE OF 1,250 SACKS (3,000 BUSHELS) OF WHEAT THRESHED IN NORTHERN IDAHO. THE SACKS ARE PILED IN THE FIELD AND THEN HAULED TO GRAIN WAREHOUSE FOR MARKET.

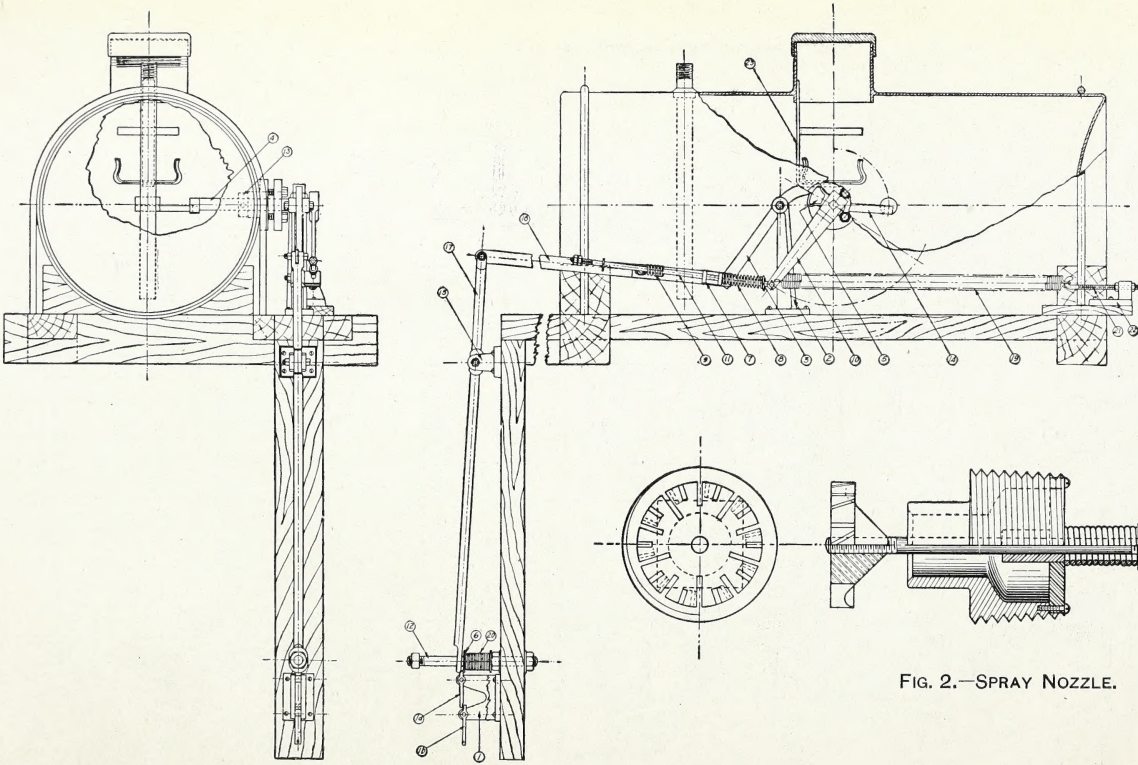
FIG. 1.—DETAIL OF AUTOMATIC FIRE EXTINGUISHER.

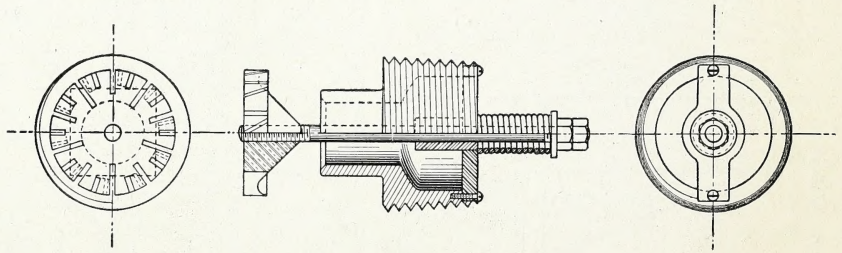
FIG. 2.—SPRAY NOZZLE.

A special nozzle was designed for use with this extinguisher. It is shown in detail in figures 2, Plate XI.
